Signage and Lighting Configuration Design for Bus Safety

Submitted to Transport Chicago 2009 on May 29, 2009
Word count: $5,638 + (5 \times 250) = 6,888$

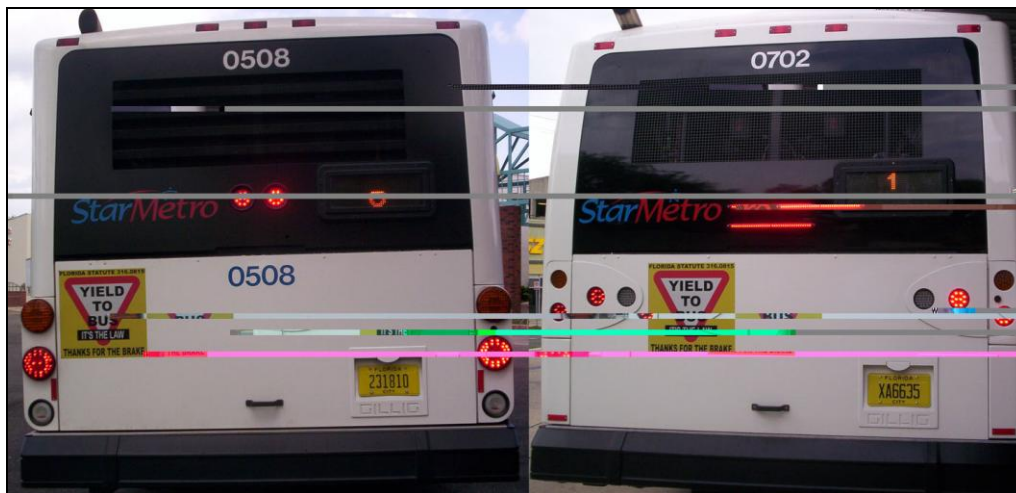
Based on the results of the literature review, preliminary bus operator surveys and the MUTCD yield sign, a new YTB decal was designed by the Center for Urban Transportation Research and produced by Next Day Signs to be tested on Starmetro buses in Tallahassee. The new decal was made larger than the average decal in Florida to see if the larger sign has any effect on a transit system that previously never employed any YTB signage or lighting. Ten decals were made using reflective vinyl. The decal was made as an 18 inch square with the Florida Statute listed. In the narrative portion of the questionnaire, some bus operators recommended a larger YTB decal; therefore the new test decal was made larger than the typical decals seen in Florida. The red triangle, which is the sign used in the MUTCD was also made brighter and more like the MUTCD yield sign. The basic elements of the YTB decal were made similar to other YTB decals used in Florida. Figure 1 shows the pictures of new decal on the back of bus. The decals were restricted to buses that did not have advertising on the back and also to the newer Gillig buses since the older RTS models did not have adequate space to accommodate an 18 inch decal. The lighting configuration on the back of the buses constrained the exact location of the decal. On the older Gillig buses, the decal could be placed in the corner of the rear door panel but on the newer Gillig models, the decal had to be placed closer to the center to avoid the rear lights.

FIGURE 1 New Decal Placements on Starmetro Buses

Operator questionnaires were then distributed 2 weeks after the new decals were implemented to see if they noticed any difference in motorists' behavior after 2 weeks. Forty-one percent of operators said there was a noticeable difference in yield behavior but a few operators commented in the narrative section that they are still not used to the new decals.
